**RE: Sub-Slab Depressurization System (SSDS) – Annual Inspection Report**

Aztech Technologies, Inc. (Aztech) is pleased to provide the following report of the annual SSDS inspection. The purpose of this report is to present the findings of the SSDS inspection conducted at the former Magna Metals site located at 510 Furnace Dock Road, Cortlandt Manor, NY.

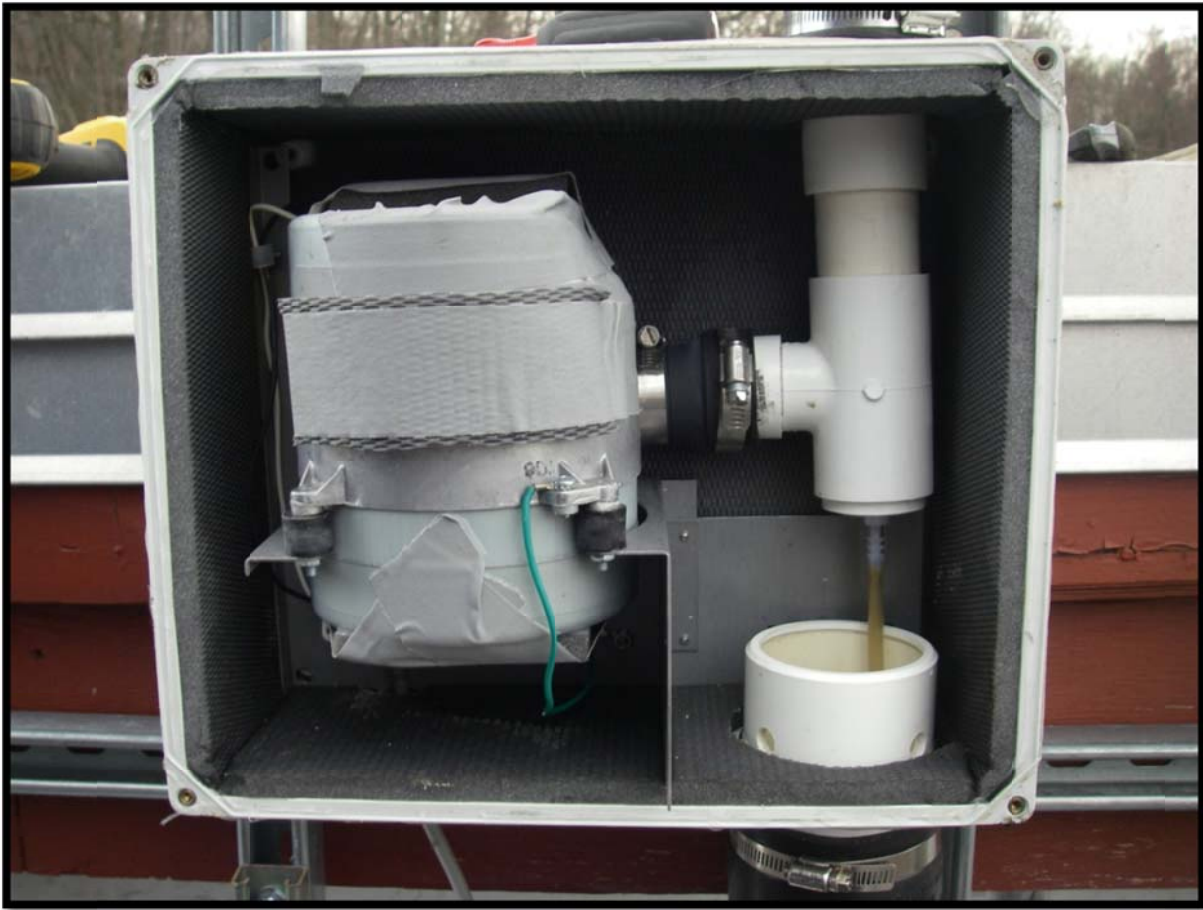
On December 26<sup>th</sup>, 2013, during a routine inspection of the vacuum indicator lights, the building tenant observed that one of the three lights was illuminated. Aztech was notified the same day by the property manager. On December 30<sup>th</sup> 2013, Aztech mobilized to the site and confirmed that fan #1 was not running. After multiple attempts troubleshooting and testing it had been determine that the motor had overheated multiple times due to excessive vacuum. After further examination, it had been determined that the motor coils had experienced irreversible damage. While on site fan #2 was tested and displayed amperage above the maximum rated amperage. This fan also showed signs of continuous overheating and potential failure.

**Seen here is fan #1 with its protective casing removed. Technicians troubleshooted the fan and motor while on site. The fan was brought back to the shop for additional evaluation.**

On March 5<sup>th</sup>, 2014, fan #1 and fan #2 were replaced with HS-2000 model Radon mitigation fans (previously HS-5000). This model serves the purpose to provide soil vapor mitigation without the excessive vacuum and subsequent overheating which the previous model endured. Air bleed valves were also installed into the existing piping in order to calibrate the level of suction and amperage that the new fans were drawing. This addition will greatly increase the longevity of the system fans. Fan #3 was found to be in good working condition (previously replaced with HS-2000).

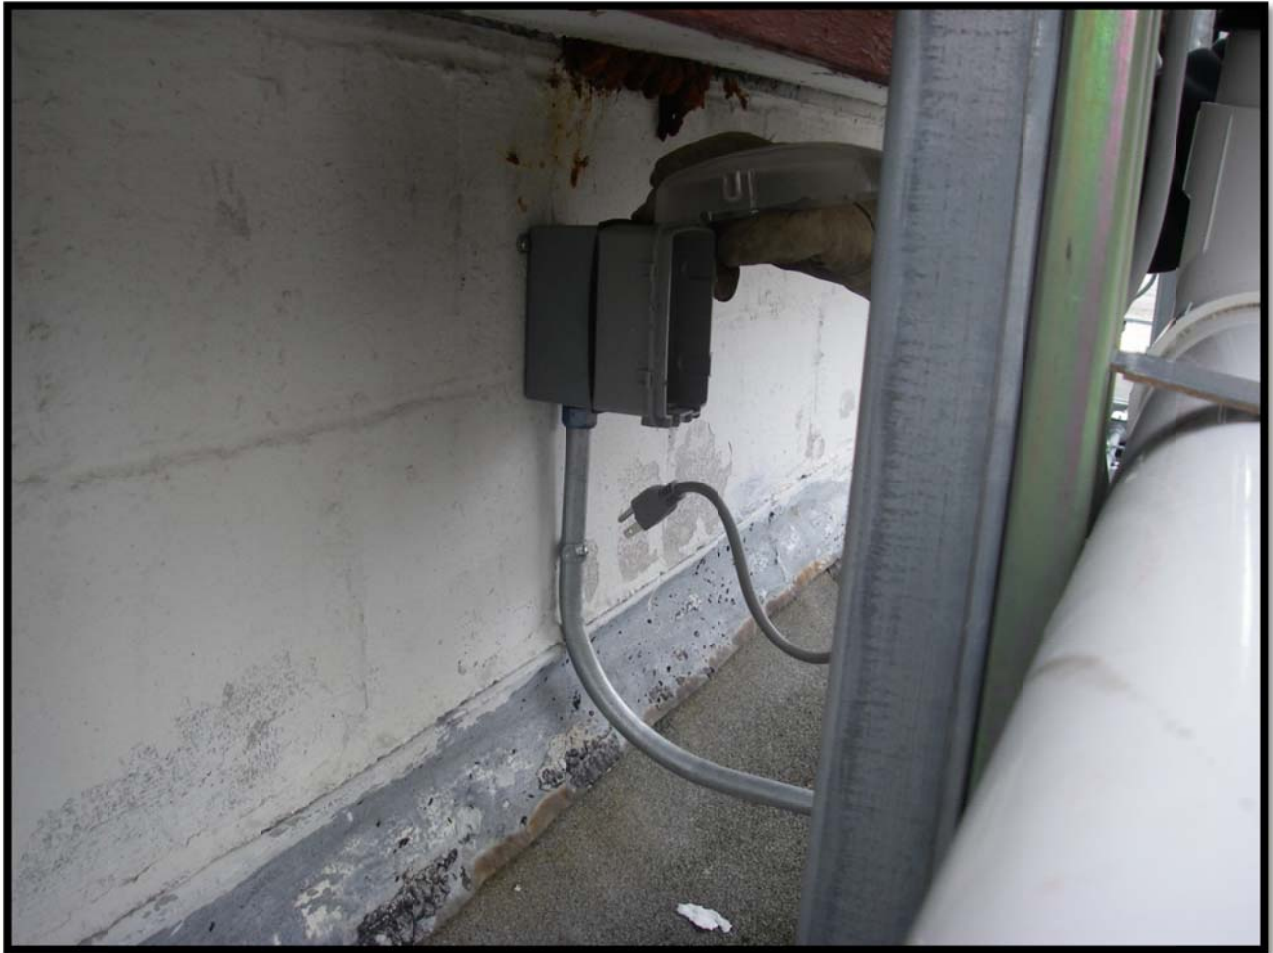
**Seen here is fan #2 temporarily unplugged, as it was drawing amperage above its max rating**

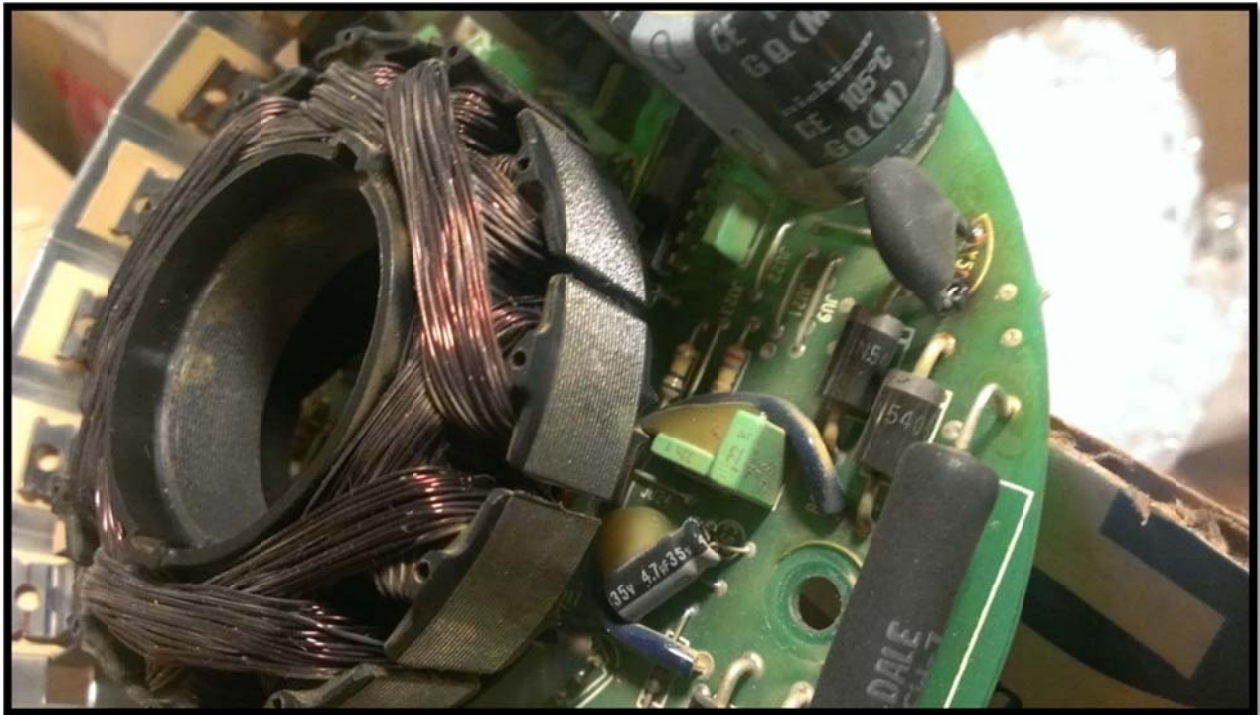
Seen here is the overheated motor coils and burnt out fuses in the upper right hand corner. After replacing the fuse, the motor continued to draw amperage above acceptable limits.
